Swedish Climbing Federation 2023-05-22

Safety Notice

Bolt failure

Near miss incident / safety concern

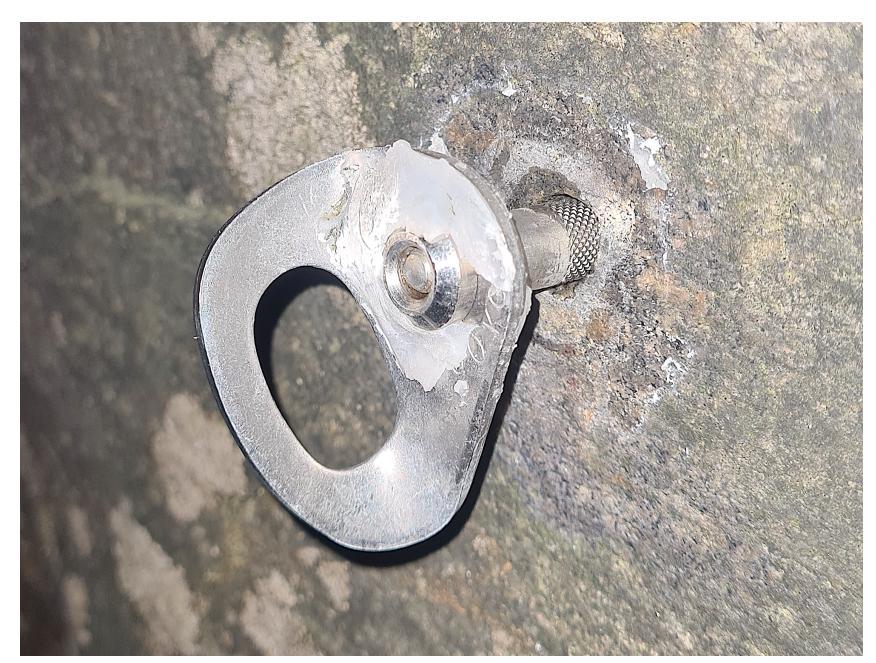
In October 2022 during inspection and inventory work by the bolting committee of Gothenburg climbing club, Sweden, a Petzl Longlife bolt was pulled out by hand (picture below).

The Petzl Longlife, type 1, pulled out by hand October 2022.

2. If any Petzl Longlife *Type 1* is found, these are replaced as soon as possible.

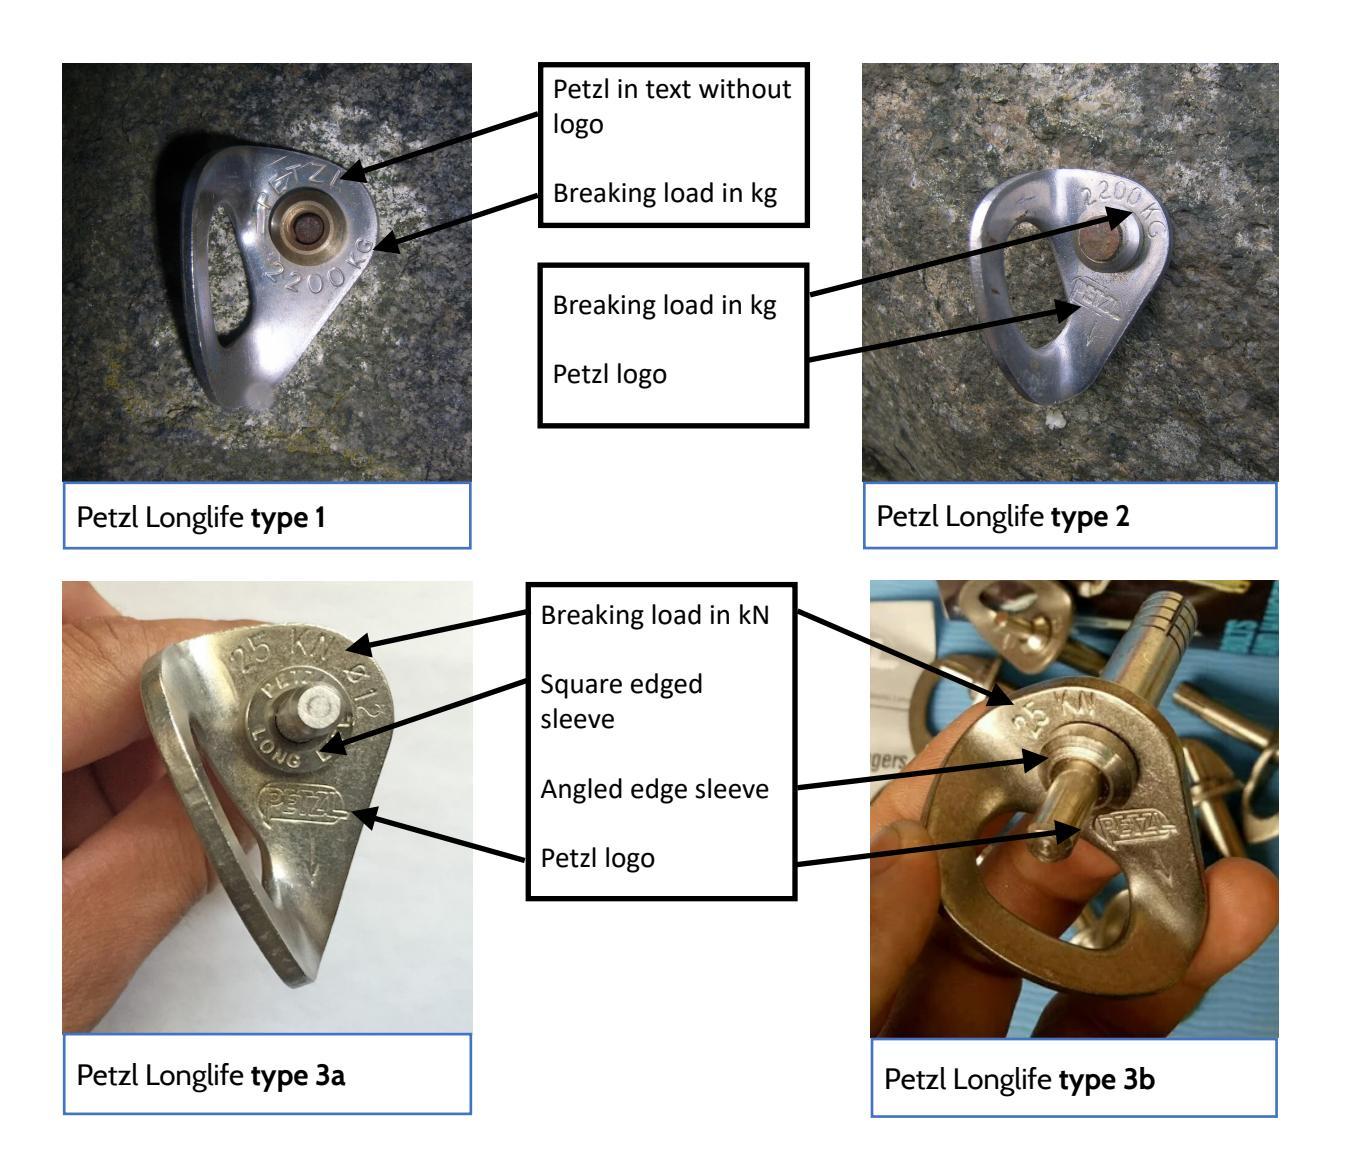
In the Gothenburg area there have been two different versions of the Petzl Longlife used: Which we call "Type 1" and "Type 2".

Type 1 has been installed 1988-1991 and *Type 2* has been installed 1990-1991.

There are also two later generations of Petzl longlife, *Type 3a* and *Type 3b*, which have not been used in the Gothenburg area and therefore we lack knowledge about these.

- 40 *Type 1* and 17 *Type 2* Longlifes have been found and tested. (Additional two *Type 2* bolts are known, and will be tested.)
- All of the *Type 2* bolts have been classified "not dangerous", according to the definition in the above mentioned test method.
- Whereas only 24 out of 40 *Type 1* bolts are classified as "not dangerous".
- The maximum force applied during removal of the bolts that didnt pass the test varied between 3 and10 kN.
- 40% of the Type 1 bolts either were pulled out with less than 6 kN load, or they couldn't hold the 6 kN load during the test and moved slightly.
